WL-TR-91-4032
DOT/FAA/CT-91/23
VOL II, Part 2

COMPOSITE FAILURE ANALYSIS HANDBOOK
VOL II - TECHNICAL HANDBOOK
PART 2 - ATLAS OF FRACTOGRAPHS

R.J. Kar
Northrop Corporation
One Northrop Avenue
Hawthorne, California 90250-3277

February 1992

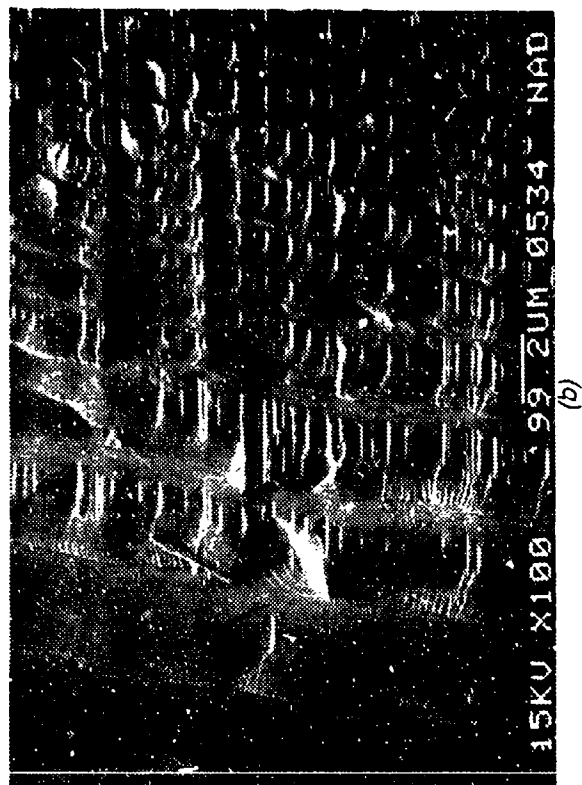
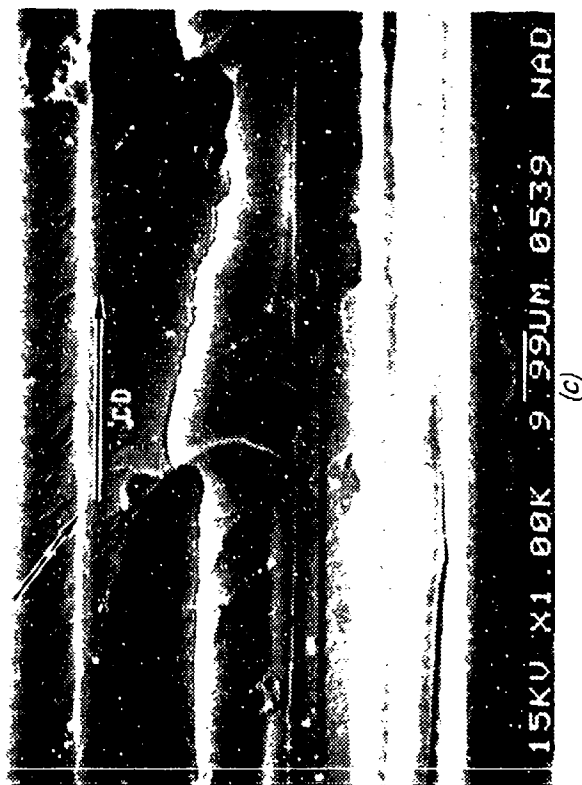
Figure 2-111. Optical and SEM Photographs of Mode I and Mode II MMF Interlaminar Fracture in Undercured Gr/Ep - [0]_{24T}
 (a) Macro photograph showing Regions I, II, and III (Pre-crack, Mode I and II Growth, and Laboratory Overload)
 (b) Mode I Tension Fracture Initiation in Resin-Rich Areas
 (c) River Patterns (Arrows) on Fractured Epoxy
 CD = Crack-propagation direction

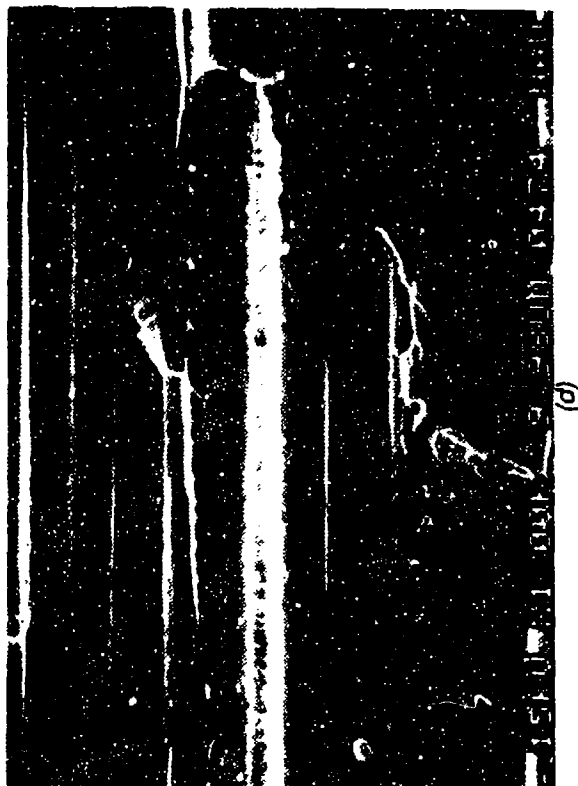
Figure 2-111. (Continued)
 (d) Local Porosity (P) in Region I
 (e) Interface Between Mode I and Mixed-Mode Regions
 (f) River Patterns (Arrows) and Hackles (H) in the Mixed-Mode Region
 CD = Crack-propagation direction

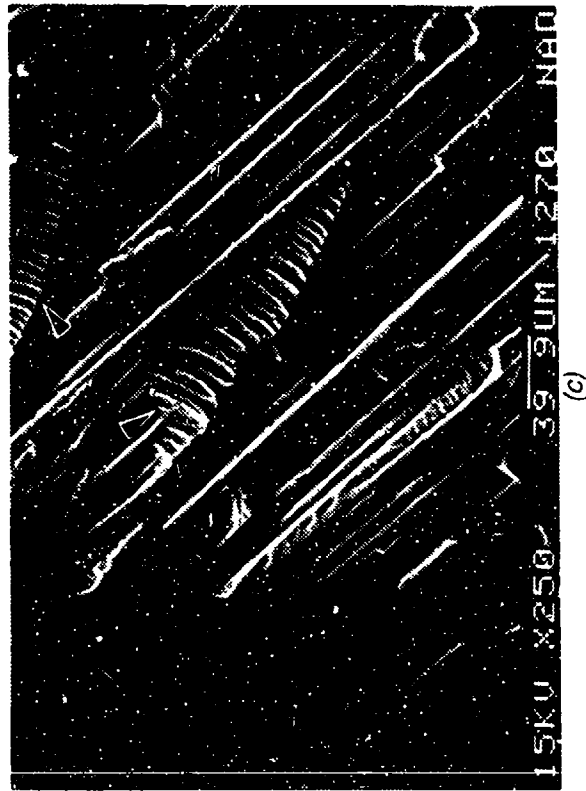
Figure 2-112. Optical and SEM Photographs of Mode I and Mode II
MMF Interlaminar Fracture in Undercured Gr/Ep -
[+45/0/-45] ₄₅
(a) Macro photograph
(b) Initiation in Precrack
(c) High Magnification Photograph of Precrack
Showing River Patterns (R)

CD = Crack propagation direction

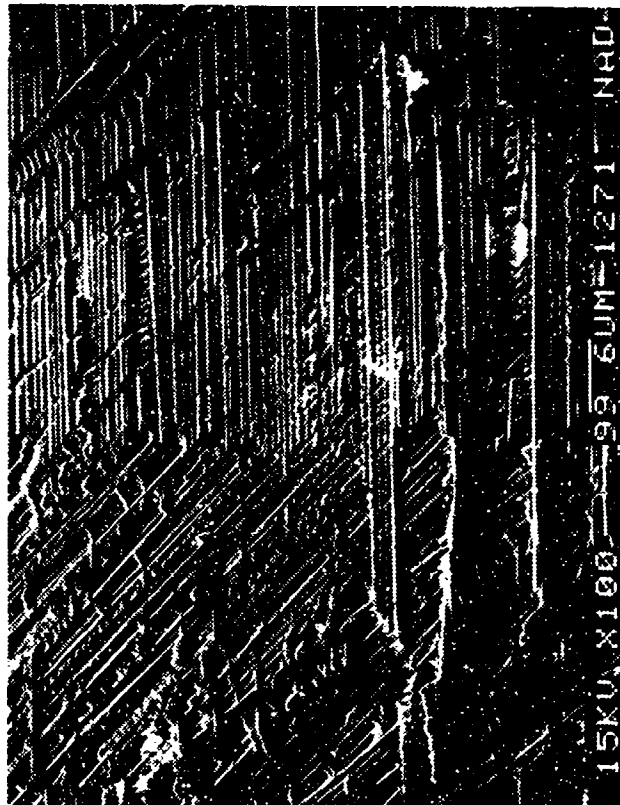
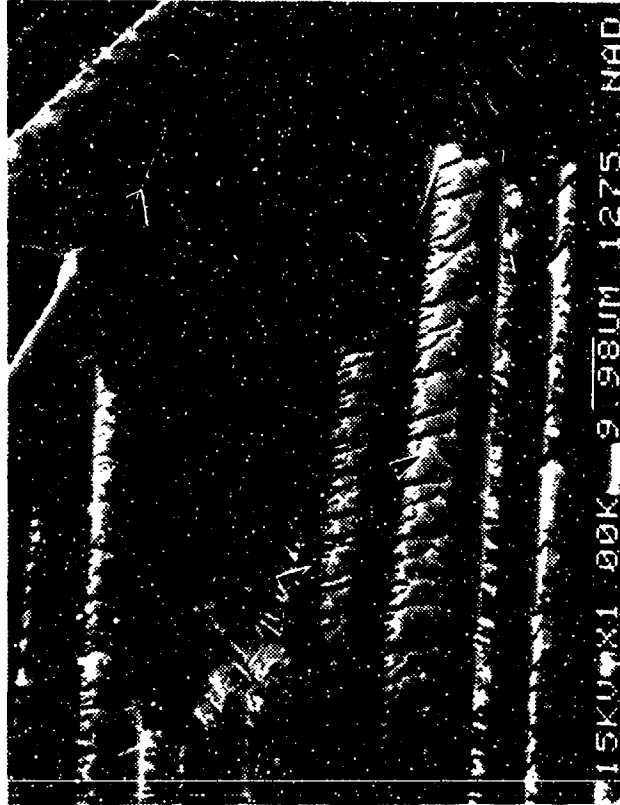
Figure 2-112. (Continued)
 (d) Mode I/Mixed-Mode Interface
 (e) Mixed-Mode Region
 Note local deviation of river patterns from CD

CD = Crack-propagation direction
 H = Hackles
 R = River patterns

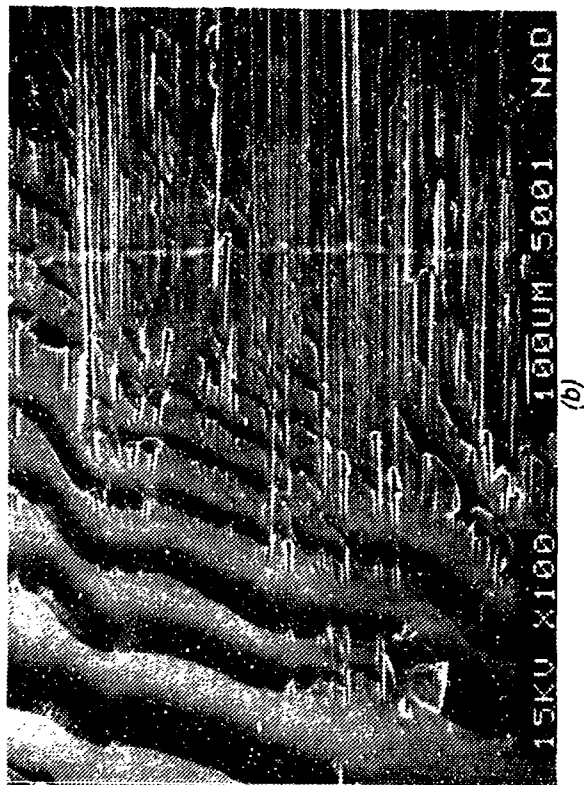
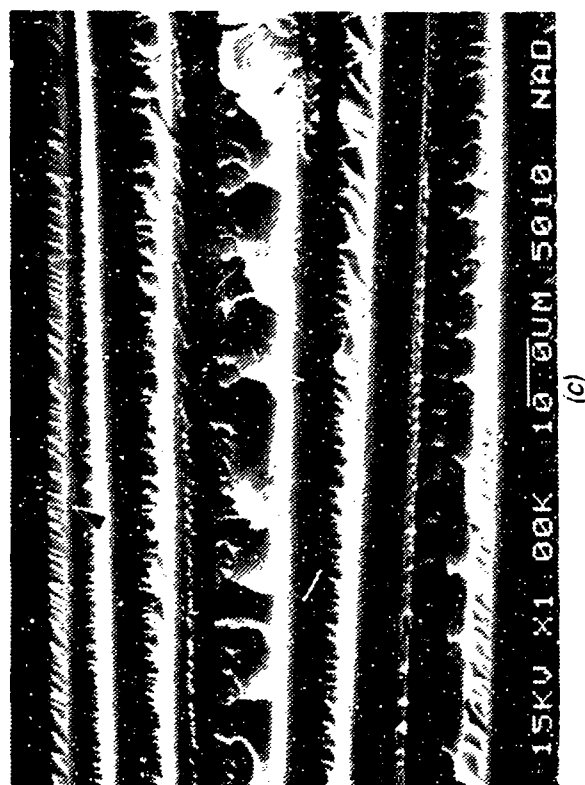
Figure 2-113. Optical and SEM Photographs of Mode I and Mode II MMF Interlaminar Fracture in Overcured Gr/Ep - [0]₂₄T
(a) Macrograph Showing Regions I, II, and III
(b) Pre-crack, Crack-Growth Under Mode I Tension and Mode II Shear, and Laboratory Overload
(c) Initiation in Resin-Rich Areas
(d) Mode I River Patterns (Arrows)

CD = Crack propagation direction

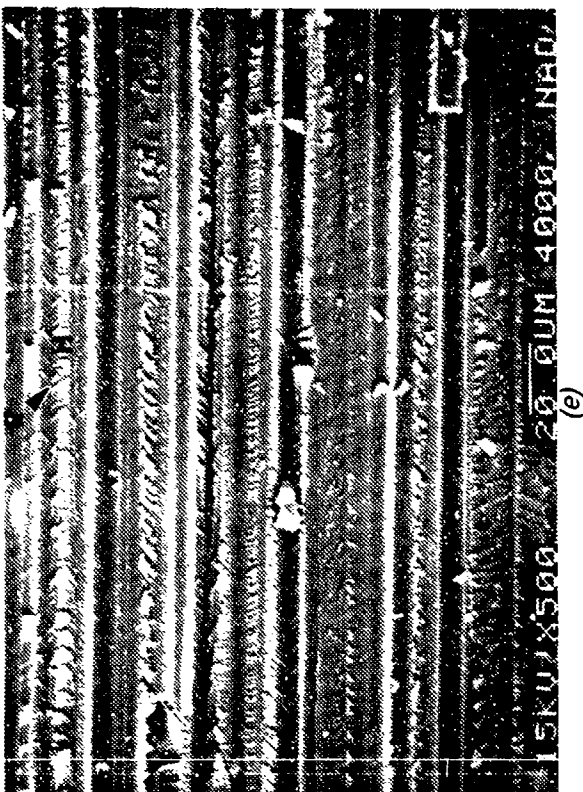
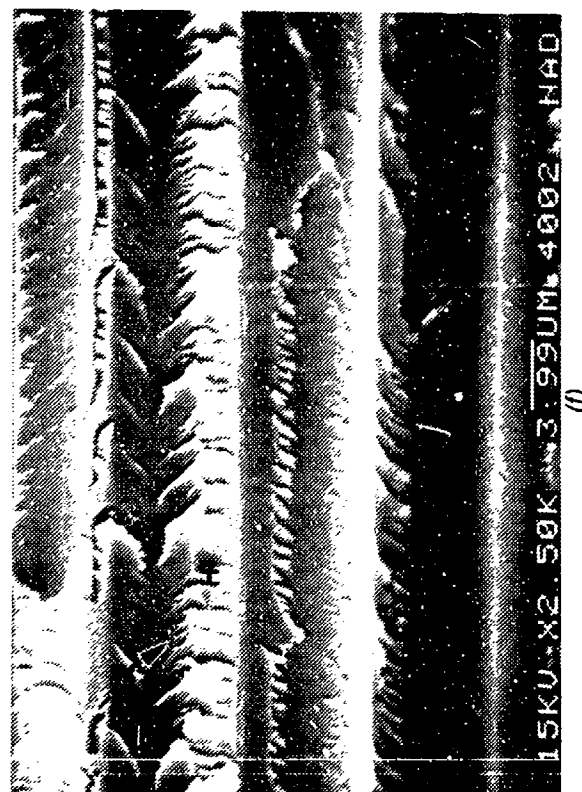
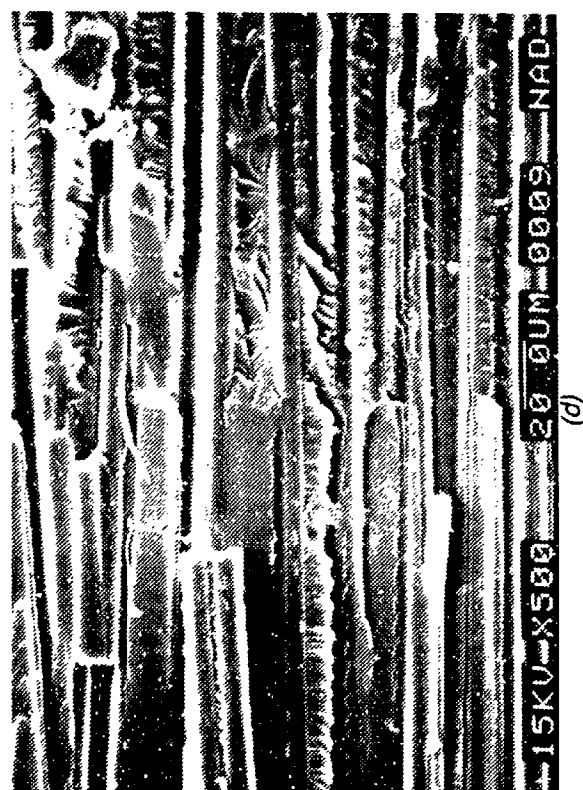
Figure 2-113. (Continued)
 (d) Interface Between Mode I and Mixed-Mode Regions
 (e), (f) River Patterns (R) and Hackles (H) in the Mixed-Mode Fracture Surface

CD = Crack-propagation direction

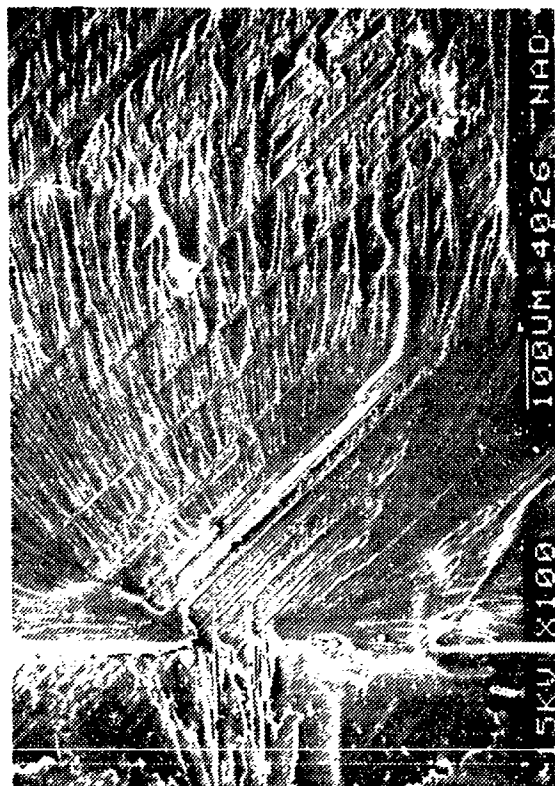
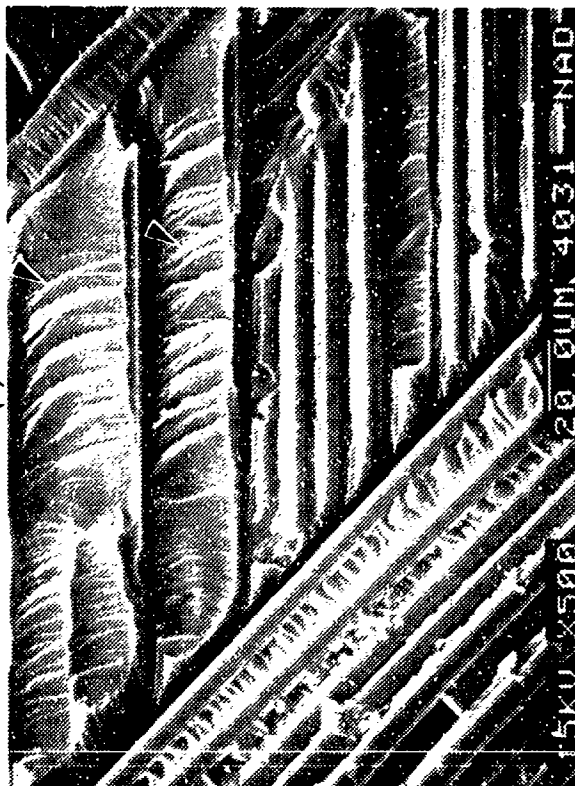
(c) Mode I River Patterns (Arrows)

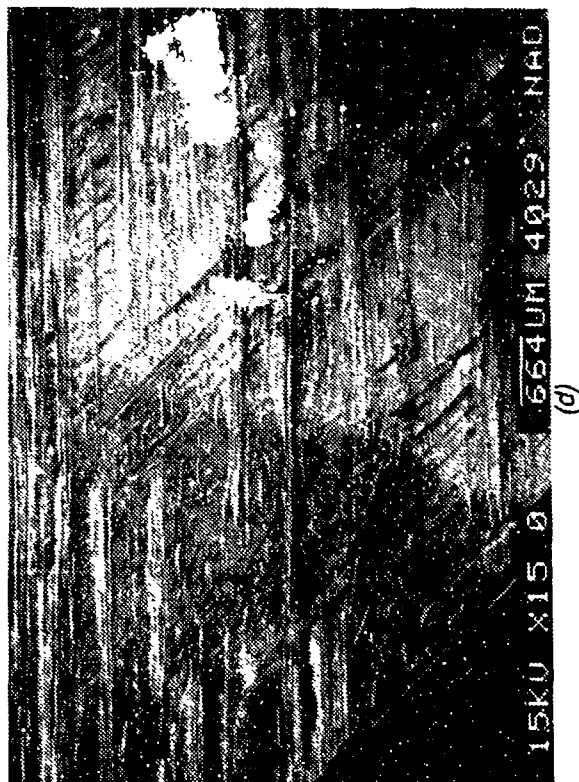
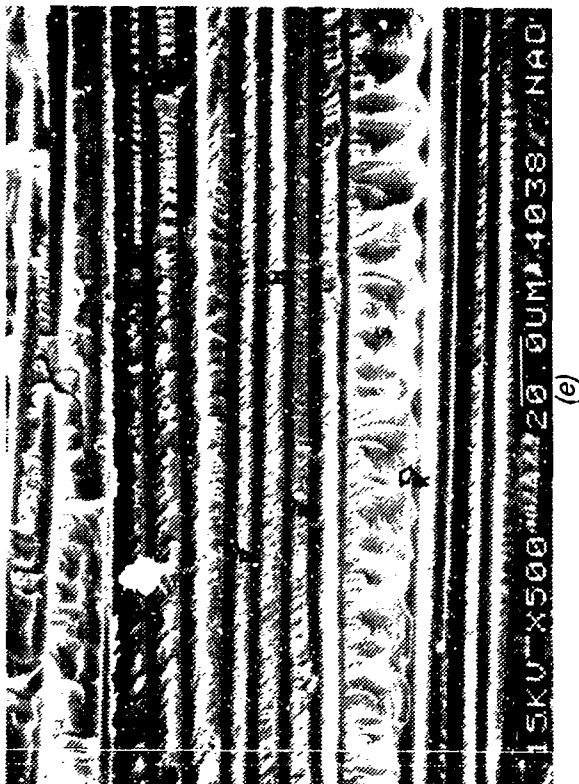
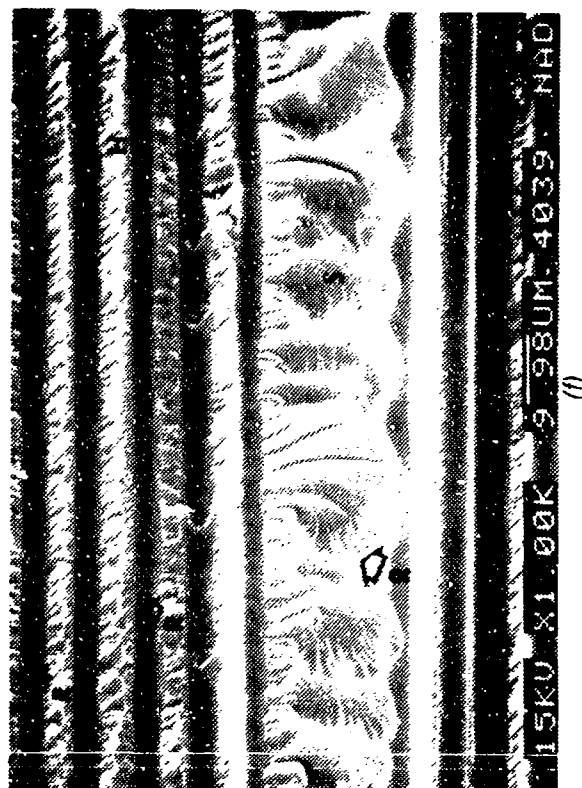
Figure 2-114. (Continued)
 (d) Interface Between Mode I and Mixed-Mode Regions
 (e), (f) River Patterns (R), Hackles (H), and Scallop (S) in the Mixed-Mode Fracture Surface
 CD = Crack-propagation direction

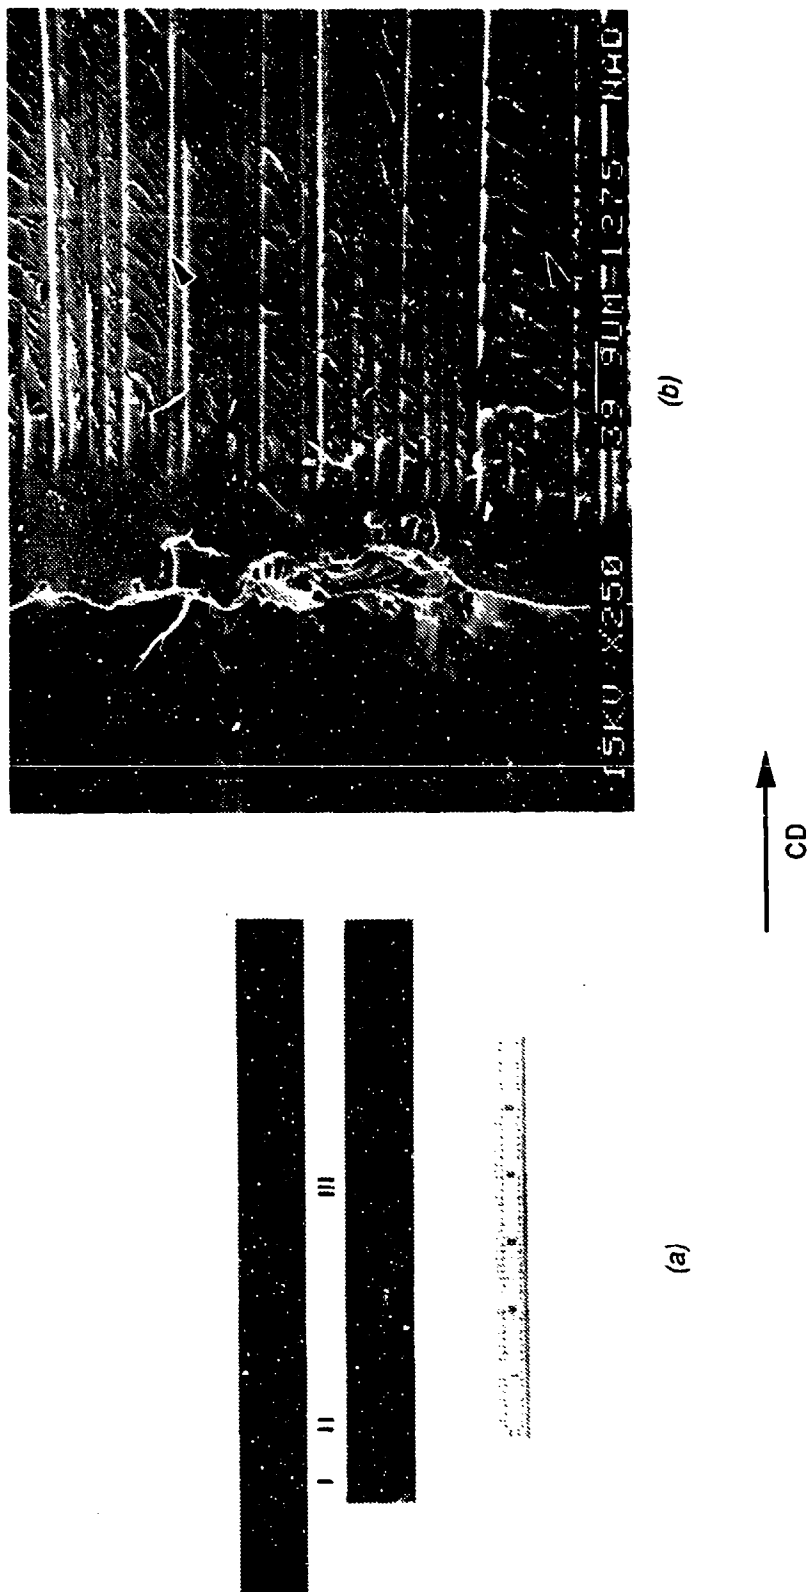
Figure 2-115. Optical and SEM Photographs of Mode I and Mode II MMF Interlaminar Fracture in High Resin Content Gr/Ep - $[0]_{24T}$

(a) Macro photograph

R = River patterns

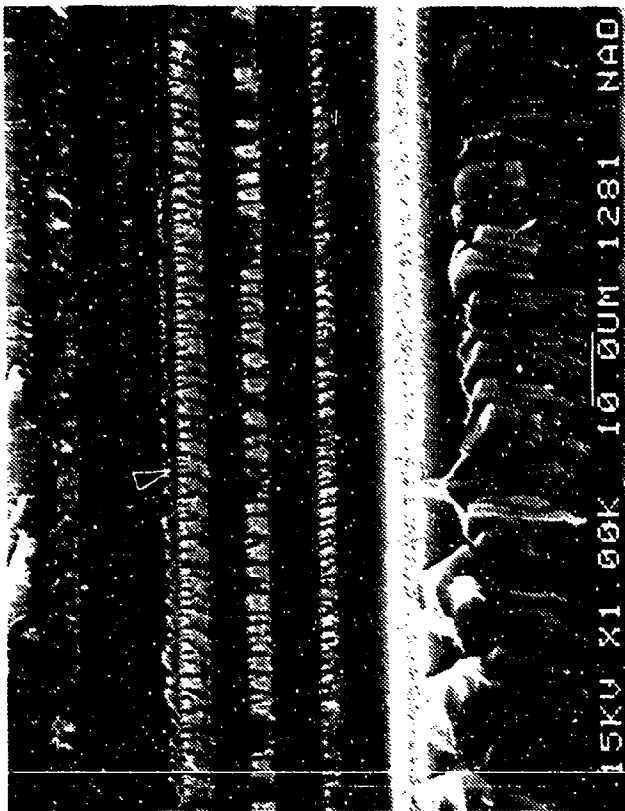
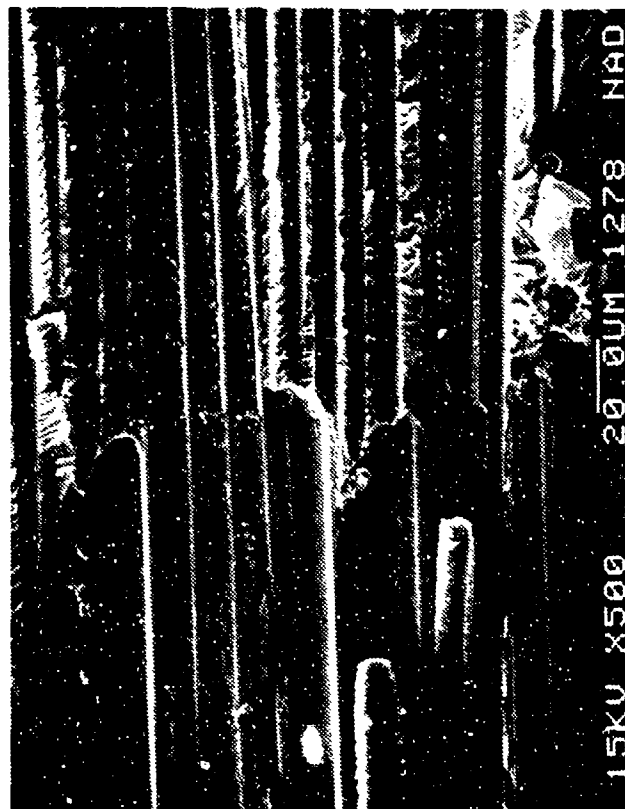
Figure 2-115. (Continued)
 (c) Mode I/Mixed-Mode Interface
 (d) Mixed-Mode Region

CD = Crack-propagation direction
 H = Hackles (Cusps)
 R = River patterns

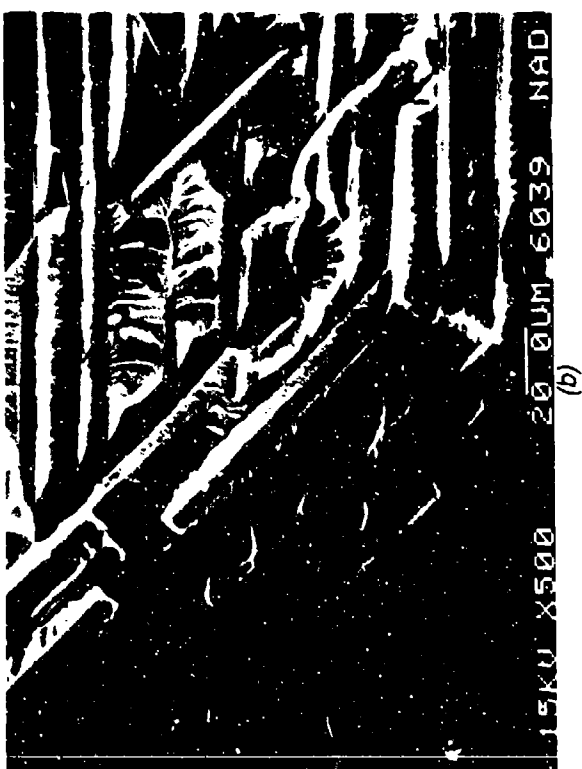
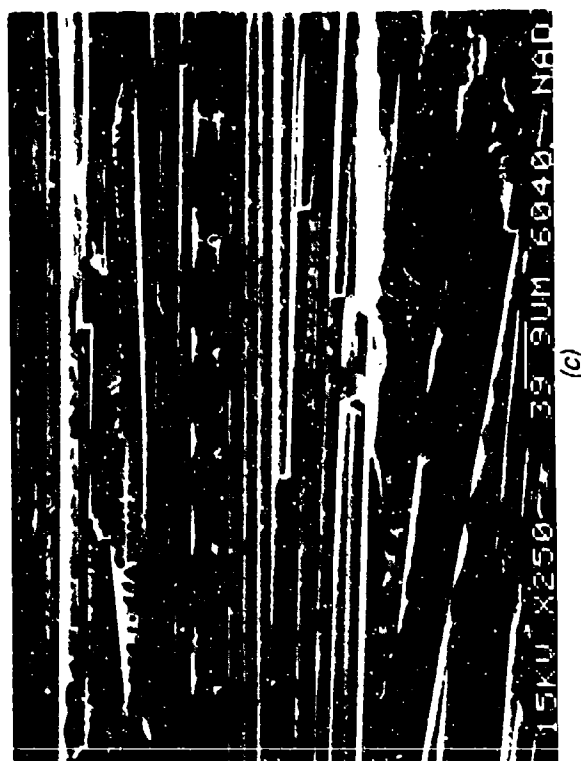
Figure 2-117. SEM Photographs of Mode I and Mode II MMF Interlaminar Fracture in Overcured Gr/Ep - [+45/0/-45] _{4s}, Conditioned 180 F/Wet After Test
(a) Mode I Tension to Mixed-Mode Transition
(b) Detail in Transition Region
(c) Mixed-Mode Fracture

CD = Crack-propagation direction
H = Hackles
R = River patterns

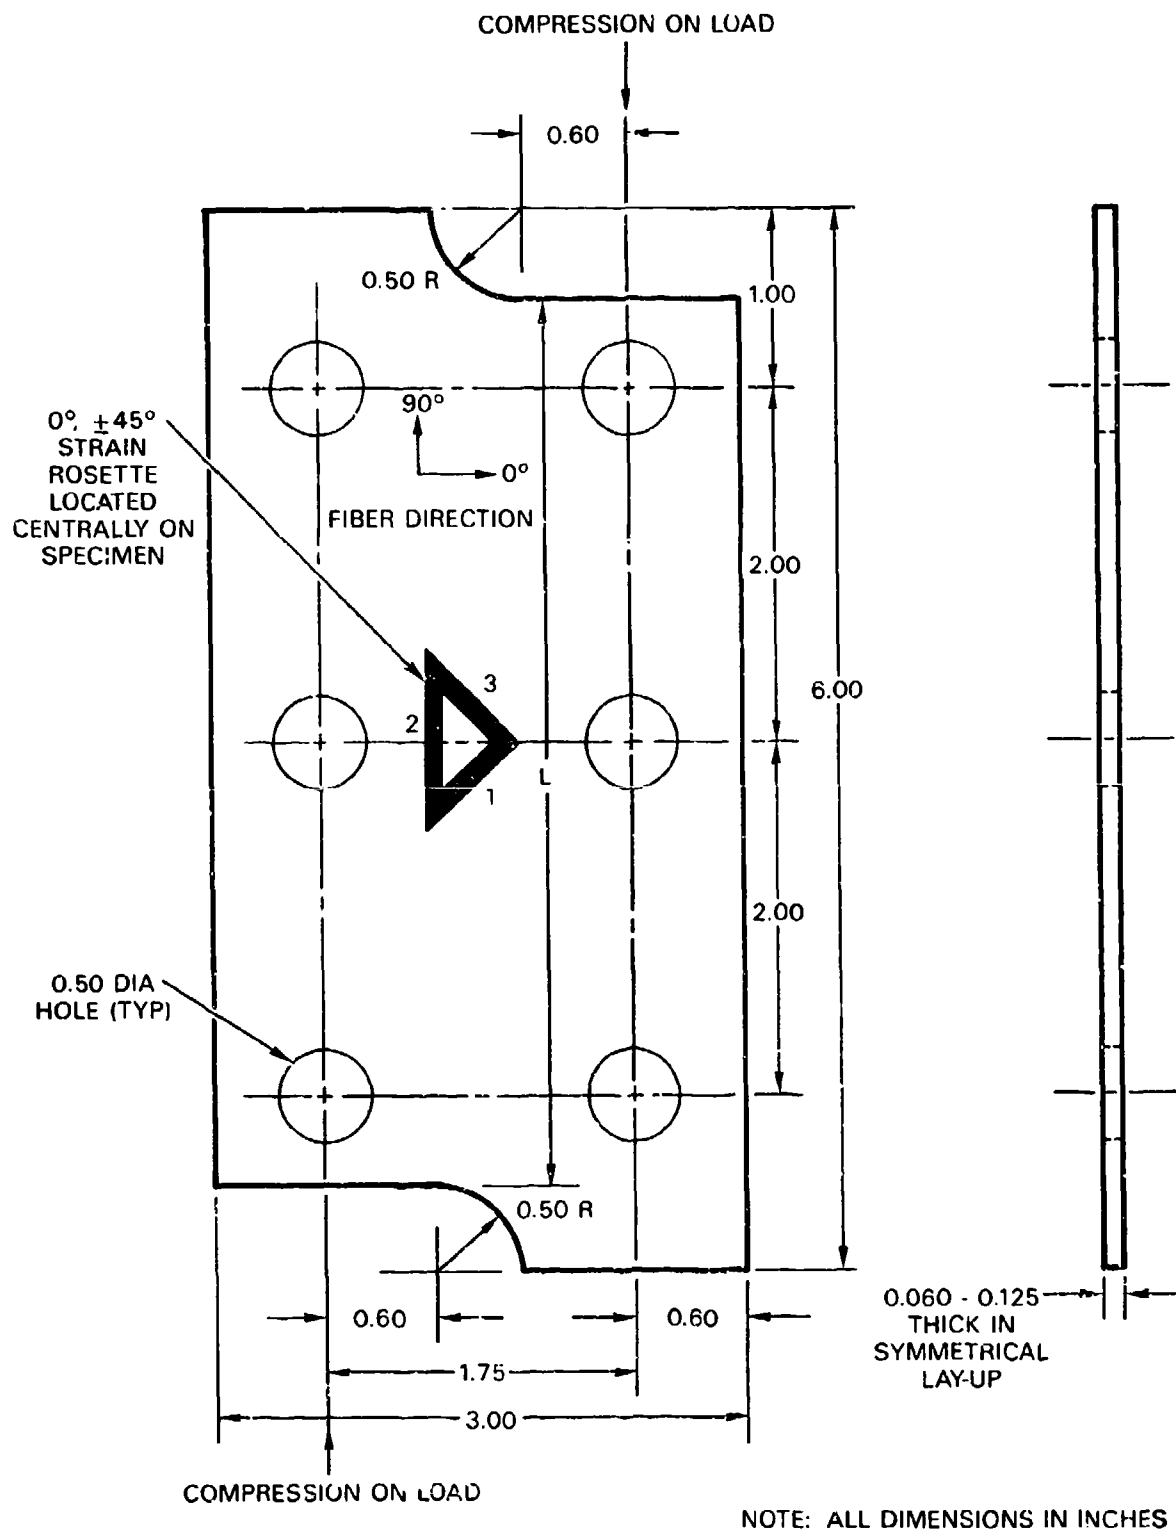
Figure 2-118. Rail-Shear Specimen

Table 2-4 shows the test matrix used for characterized in-plane shear failures in Gr/Ep. The test matrix includes baseline Gr/Ep, processing variations, and post-failure variables. The rail-shear test specimen is shown in Figure 2-118. The in-plane shear fractographs are provided in Figures 2-119 through 2-122. This contribution was made by Northrop.

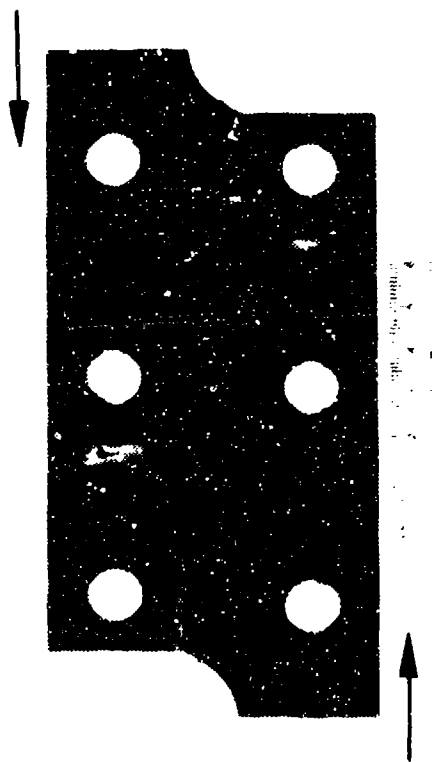
Figure 2-119. Optical and SEM Photographs of AS4/3501-6 Gr/Ep - [0/90]_{es} . In-Plane Shear-Tested (Baseline)

(b) Close-Up View of In-Plane Shear Region

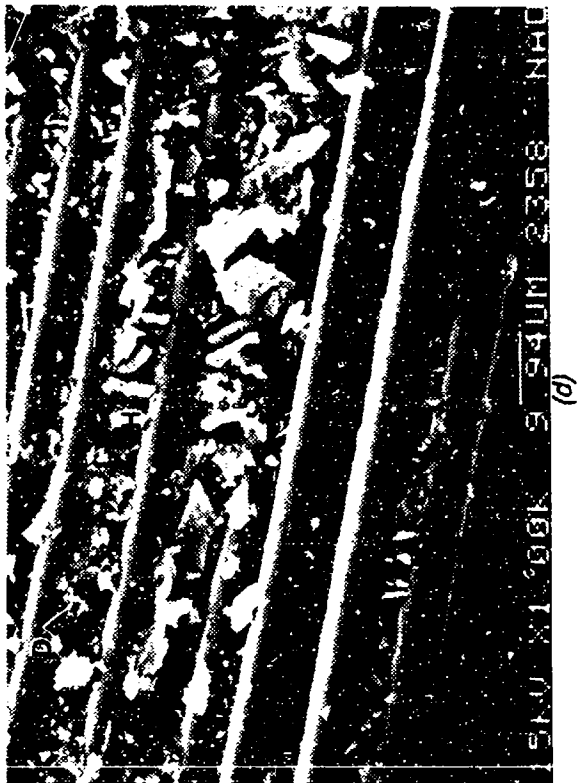
Figure 2-119. (Continued)
 (c) Delaminated Fracture Surface of Region
 Exposed by Sectioning Outer Plies
 (d), (e) Fracture in 90 and 0 Degree Plies

CD = Crack-propagation direction
 D = Compression debris
 H = Hackles

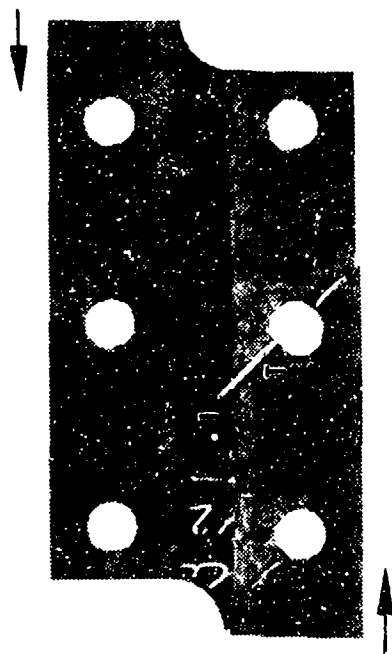
Figure 2-12c. Optical and SEM Photographs of AS4/3501-6 Gr/Ep - [+45/-45]_{6s}, In-Plane Shear Tested (Baseline)

(a) Macro photograph of Rail-Shear Specimen

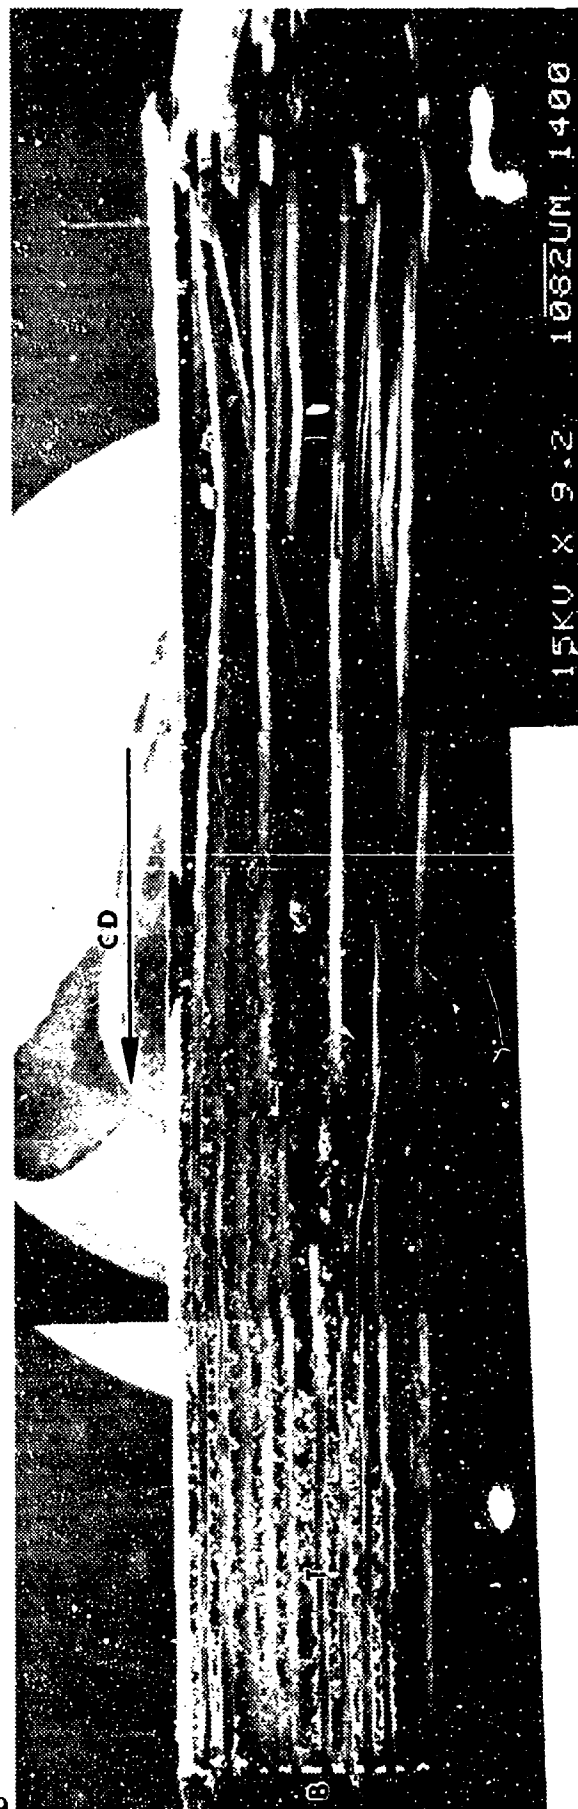
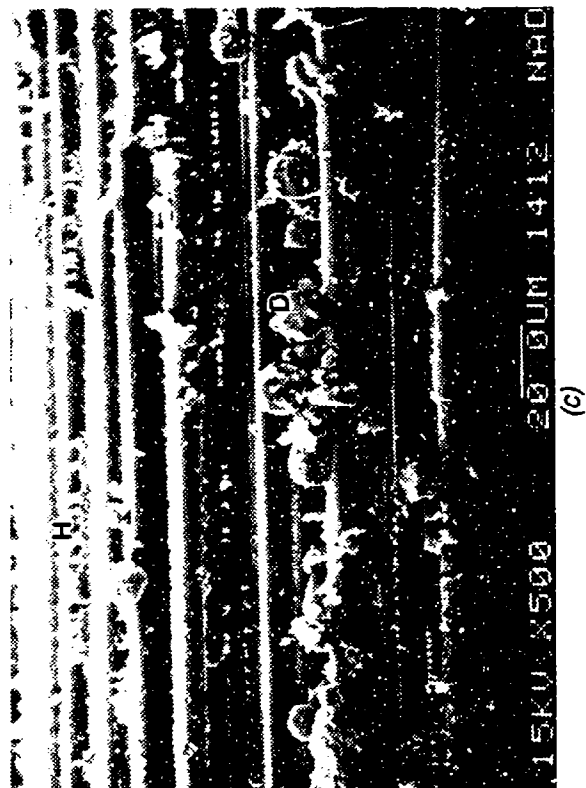
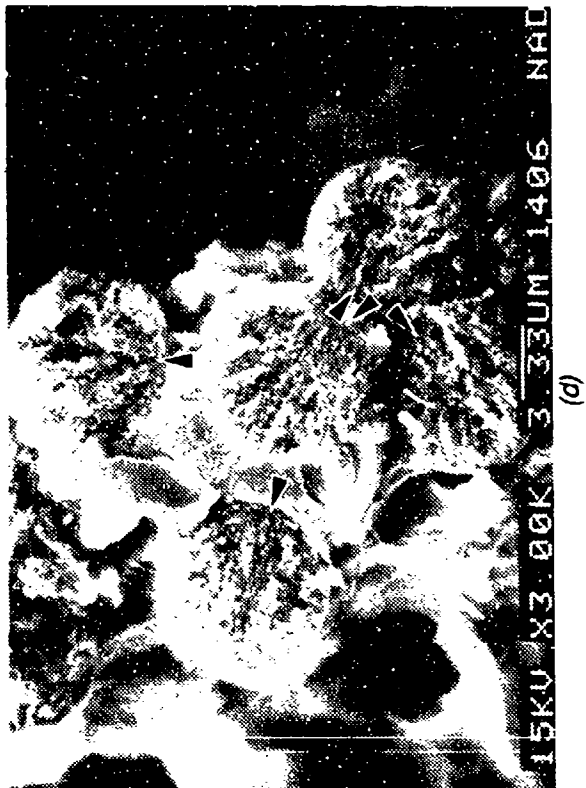
(c) Fracture in +45 Degree Ply Showing Hackles (H) and Compression Debris (D)

(d) Fracture in -45 Degree Ply Showing Tensile Fiber Breaks

(e) Transverse Tensile Fracture in Secondary Failure Region Showing Rivers (R) and Hackles (H)

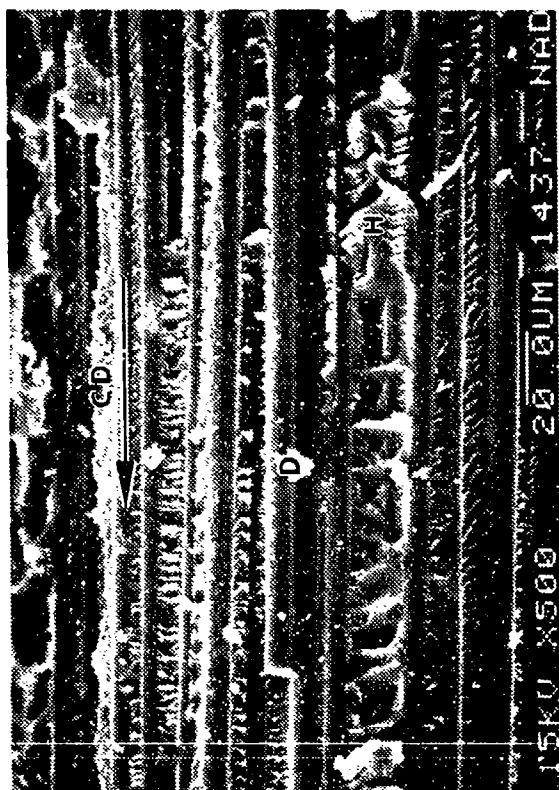
(b) Fracture in +45 Degree Ply Showing Hackles (H) and Compression Debris (D)

(c) Fracture in -45 Degree Ply Showing Tensile Fiber Breaks

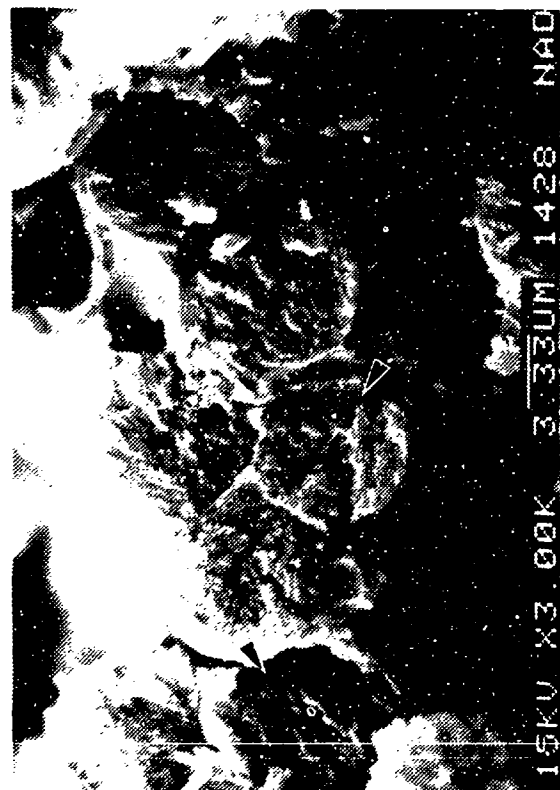
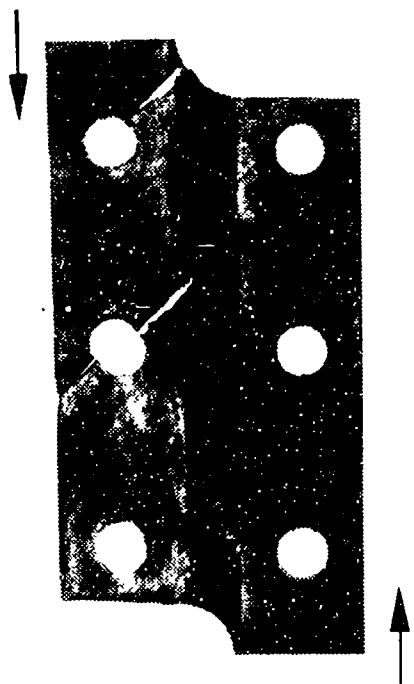
Figure 2-121. Optical and SEM Photographs of AS4/3501-6 Undercured Gr/Ep - [+45/-45]_{6s} In-Plane Shear Tested

CD = Crack-propagation direction

I = In-plane shear region

T = Secondary transverse tensile fracture

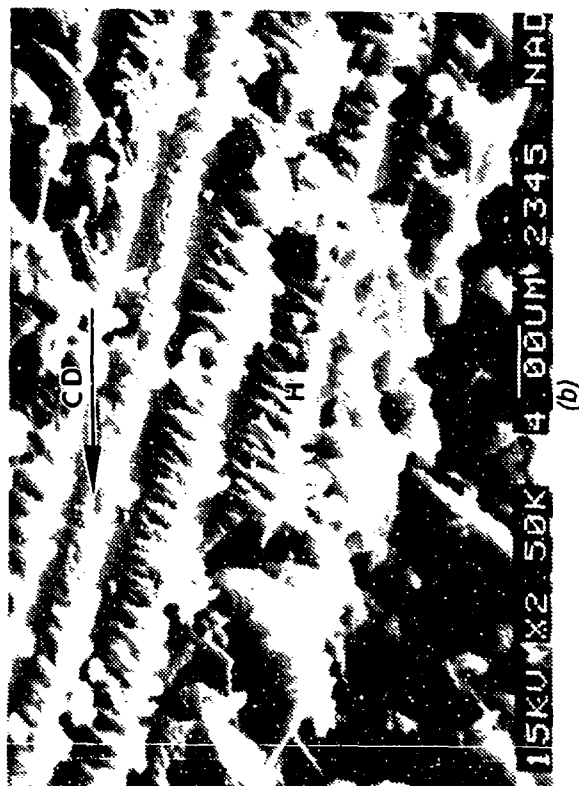
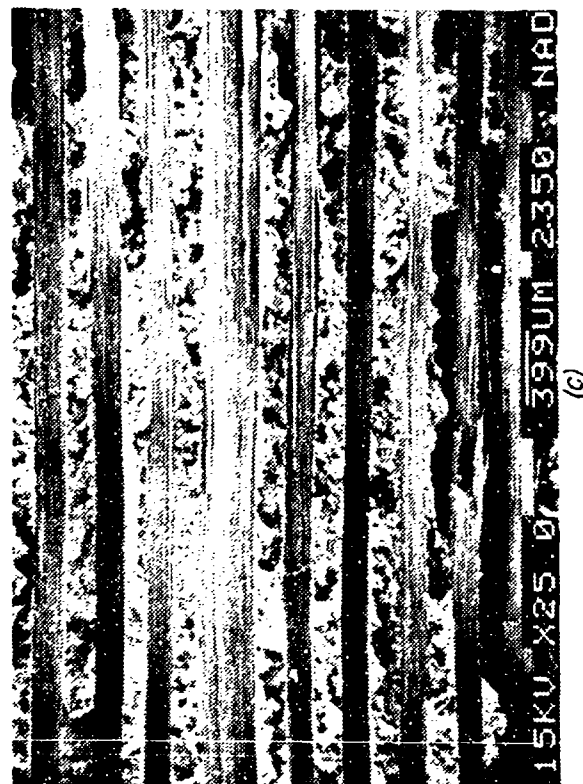
Figure 2-122. Optical and SEM Photographs of AS4/3501-6 Overcured Gr/Ep - [+45/-45]_{6s}, In-Plane Shear Tested
(a) Macrograph of Rail-Shear Specimen
(b) Fracture in +45 Degree Ply Showing Hackles (H)
(c) Transverse Tensile Fracture in Secondary Failure Region

CD = Crack-propagation direction
I = In-plane shear region
T = Secondary transverse tensile fracture

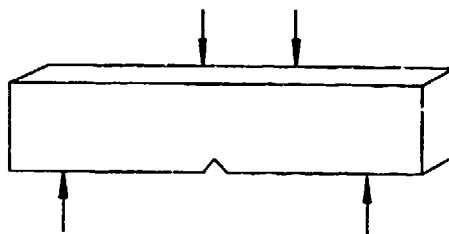
Figure 2-123. Four-Point Bend Tension Test Specimen

Figure 2-123 depicts the translaminar tension test configuration, and Figure 2-124 shows typical orientations of fibers and radial patterns of adjacent fibers at both low and high magnifications. Table 2-5 is the test matrix for the translaminar tension test specimens. Translaminar tension fractographs are shown in Figures 2-125 through 2-147. These figures are arranged in the same order that the corresponding tests are listed in Table 2-5.

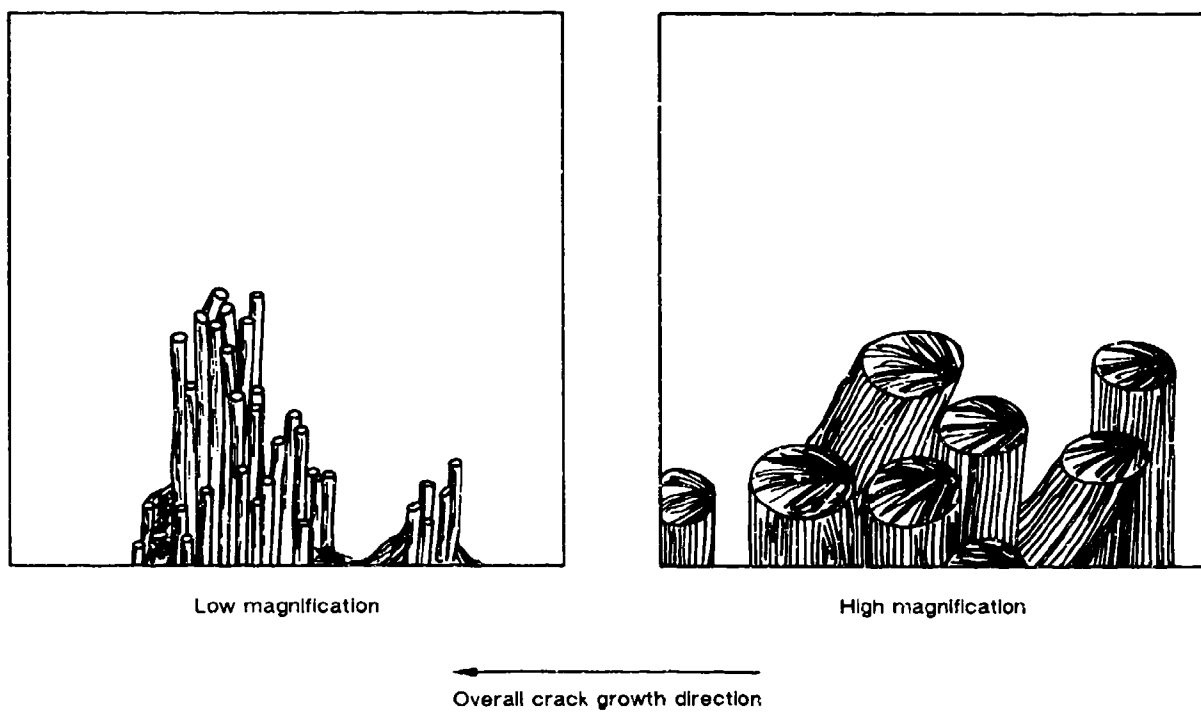
Figure 2-124. Fracture of Adjacent Fibers

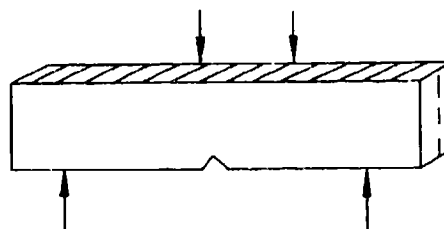
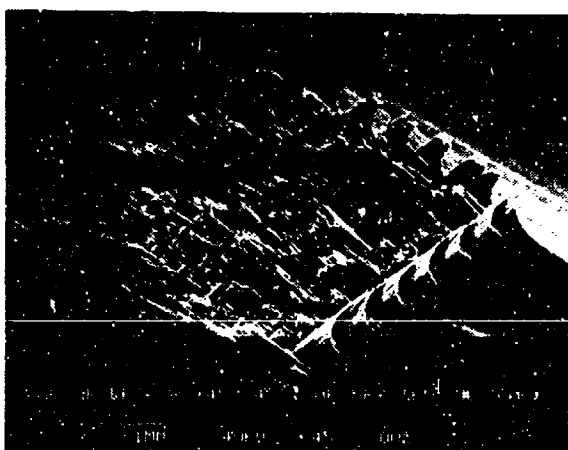
Fracture type	Translaminar mode I tension
Ply layup	[+45, -45] 16S
Test type	Four-point bend
• Test conditions	Dry
• Fiber end fracture	
Material	Hercules 3501-6/177°C cure AS4 fibers

-65°F, dry

180°F, dry

Mechanically induced crack direction

270°F, dry

Figure 2-125. SEM Photographs of Translaminar Mode I Tension, +45/-45 Fracture, -65, 180, and 270 F/Dry (Fiber Pullout)

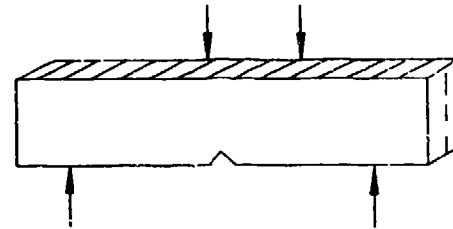
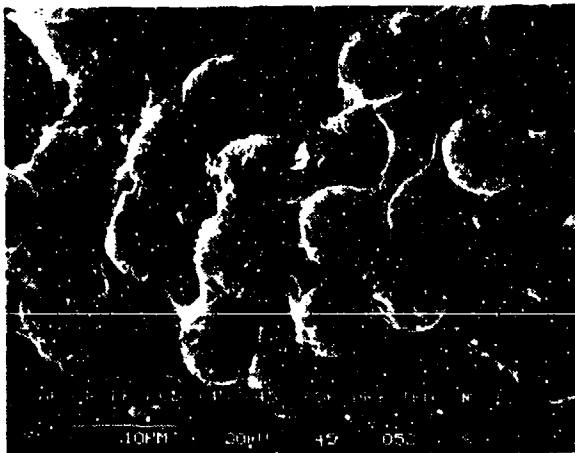
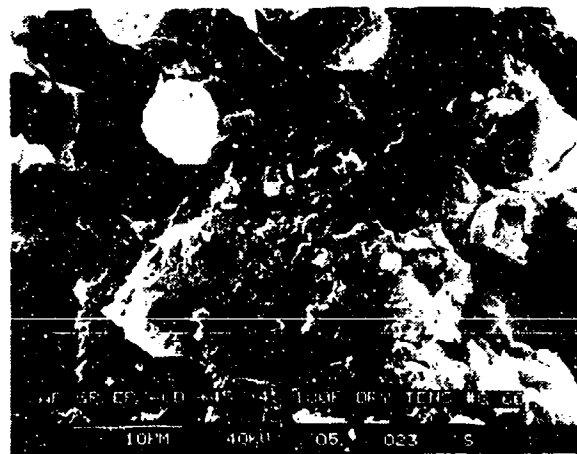
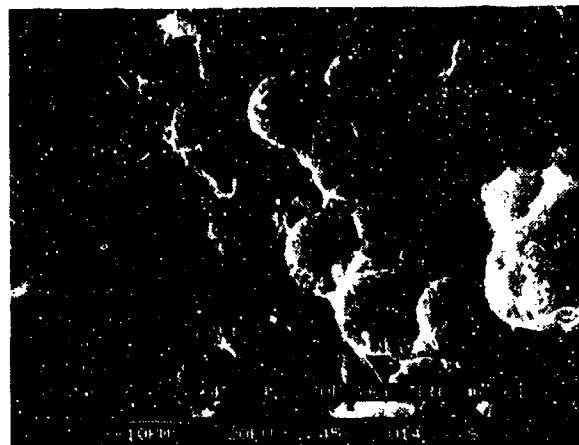
Fracture type	Translaminar mode I tension
Ply layup	[+45, -45] ₁₆ S
Test type	Four-point bend
• Test conditions	Dry
• Fiber end fracture	
Material	Hercules 3501-6/177°C cure AS4 fibers

-65°F, dry

180°F, dry

270°F, dry

Figure 2-126. SEM Photographs of Translaminar Mode I Tension, +45/-45 Fracture, -65, 180, and 270 F/Dry (Fiber Breakage)

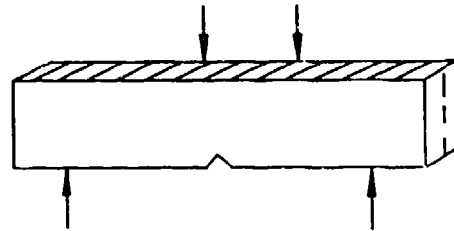
Fracture type	Translaminar mode I tension
Ply layup	[+45, -45] 16S
Test type	Four-point bend
• Test conditions	Wet
• Fiber end fracture	
Material	Hercules 3501-6/177°C cure AS4 fibers

70°F, wet

180°F, wet

270°F, wet

Figure 2-127. SEM Photographs of Translaminar Mode I Tension, +45/-45 Fracture, 70, 180, and 270 F/Wet (50X)

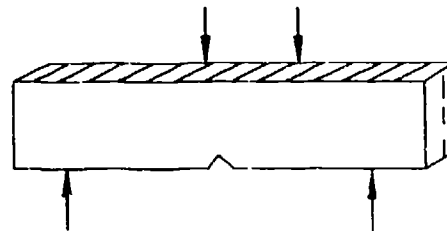
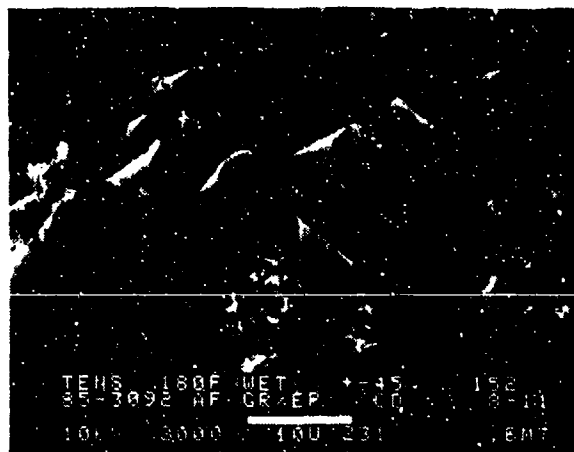
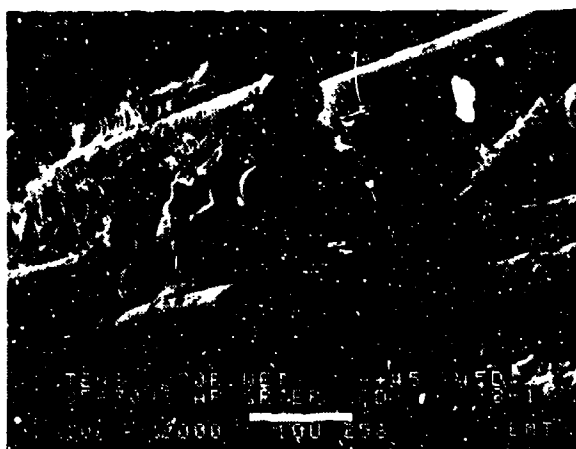
Fracture type	Translaminar mode I tension
Ply layup	[+45, -45] _{16S}
Test type	Four-point bend
• Test conditions	Wet
• Fiber end fracture	
Material	Hercules 3501-6/177°C cure AS4 fibers

70°F, wet

180°F, wet

270°F, wet

Figure 2-128. SEM Photographs of Translaminar Mode I Tension, +45/-45 Fracture, 70, 180, and 270 F/Wet (2000X)

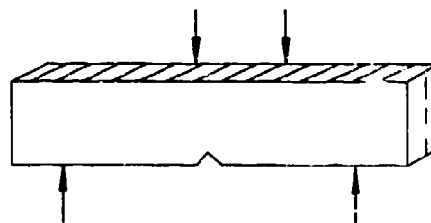
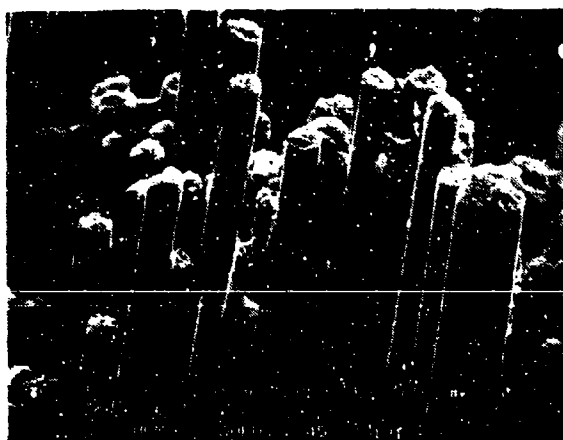
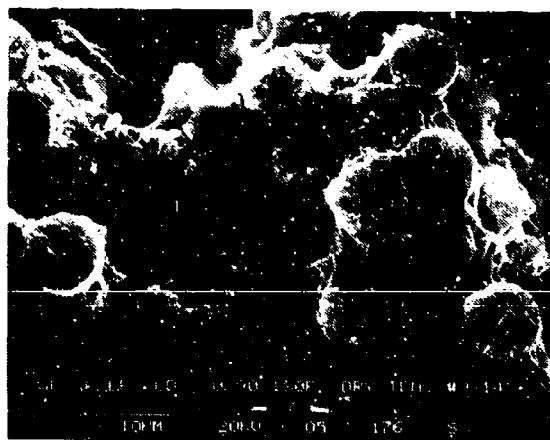
Fracture type	Translaminar mode I tension
Ply layup	[0, 90] ₁₆
Test type	Four-poin. bend
• Test conditions	82°C, dry
• Fiber end fracture	
Material	Hercules 3501-6/177°C cure AS4 fibers

←
Mechanically Induced crack direction

Figure 2-129. SEM Photographs of Translaminar Mode I Tension, 0/90 Fracture, 180 F/Dry (Various Magnifications)
